# SPRAY FOAM Insulation & Termites

This document addresses questions pertaining to inspection for, and treatment of, potential termite infestations in buildings using SPF insulation. It provides basic information about termite identification, inspection and treatments methods as well as discusses the importance of air-sealing and insulation of critical areas using SPF. It also presents code-compliant solutions to address these concerns.

## Spray Foam Insulation & Termites

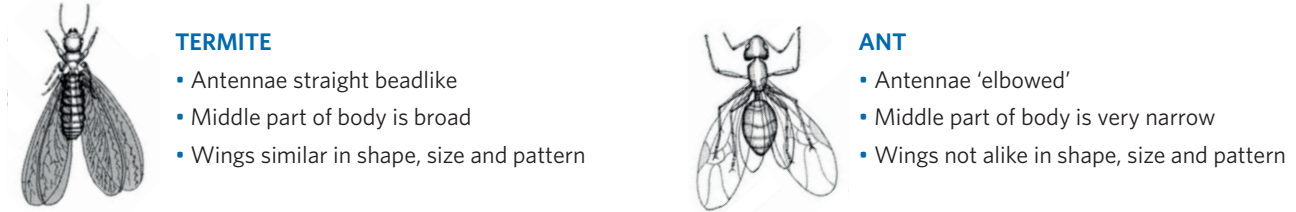
**FIGURE 1. Comparative differences between flying ants and termites**

Termites are insects that are often hard to spot and identify. To the untrained eye, flying ants can be easily mistaken for swarming (alate) termites. Figure 1 shows a comparative diagram of flying ants and termites.

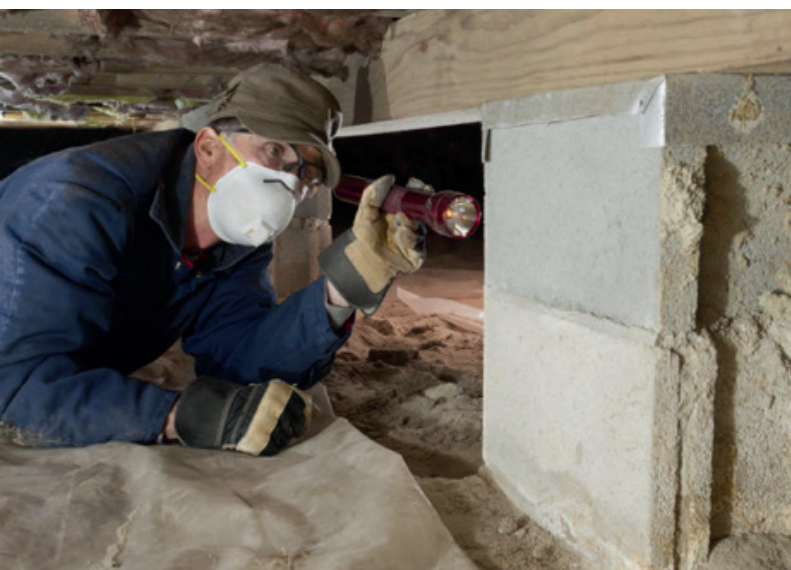
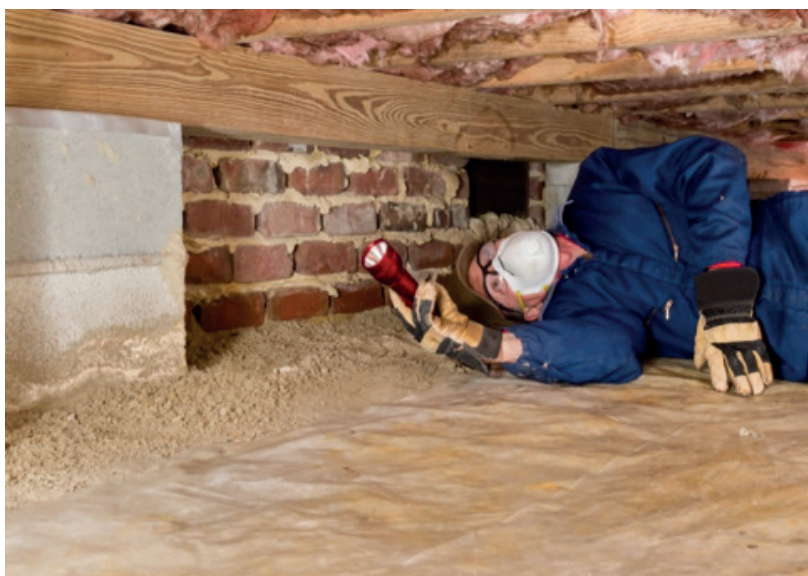
**FIGURE 3. Visual termite inspection**

The most common method to determine if termites are present in a building is by visual inspection. In a traditional visual termite inspection, a trained professional will inspect areas of the structure where termites typically enter the building and feed upon the structure (Figure 3).

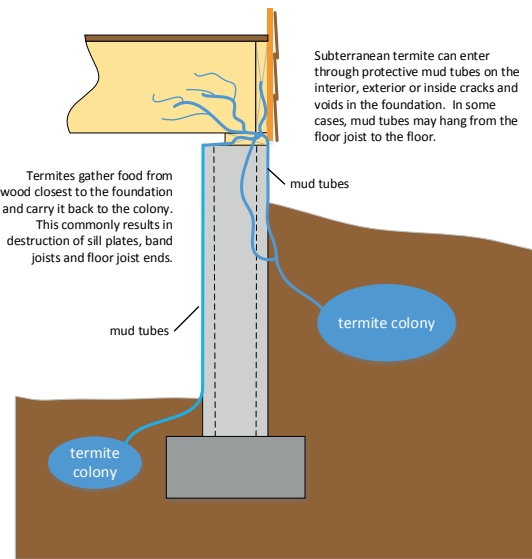
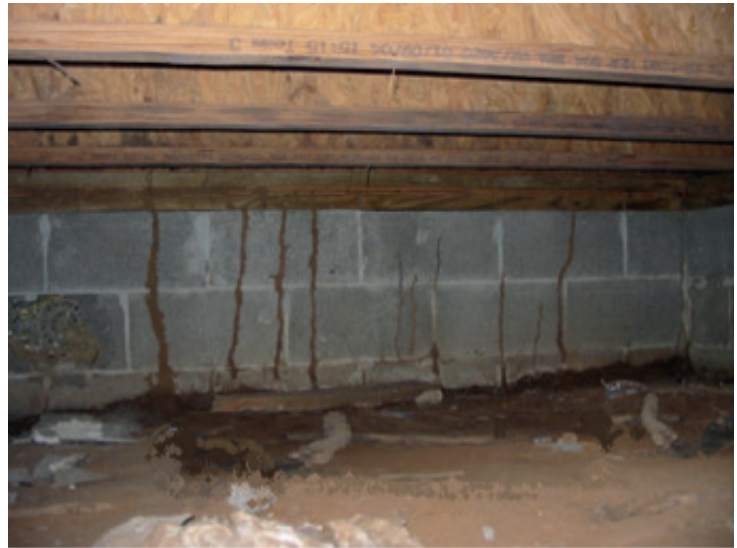
**FIGURE 4. Inspection areas and evidence of subterranean termites (mud tubes)**

Trained personnel generally inspect areas where termite infestation is likely to occur, looking for the onset of wood damage. For subterranean termites, this includes inspection of areas where the foundation meets the framing. Termite inspectors typically look for mud tubes from subterranean termites that serve as protected pathways between the underground colony and the nearby food source. Examples of mud tubes are shown in Figure 4. Inspectors also look for early damage to framing in contact with or near the foundation (sill plates, band/rim joists and floor joists). Examples of termite damage are shown in Figure 5. For drywood termites, inspectors look for frass (excrement), as well as small bore holes.

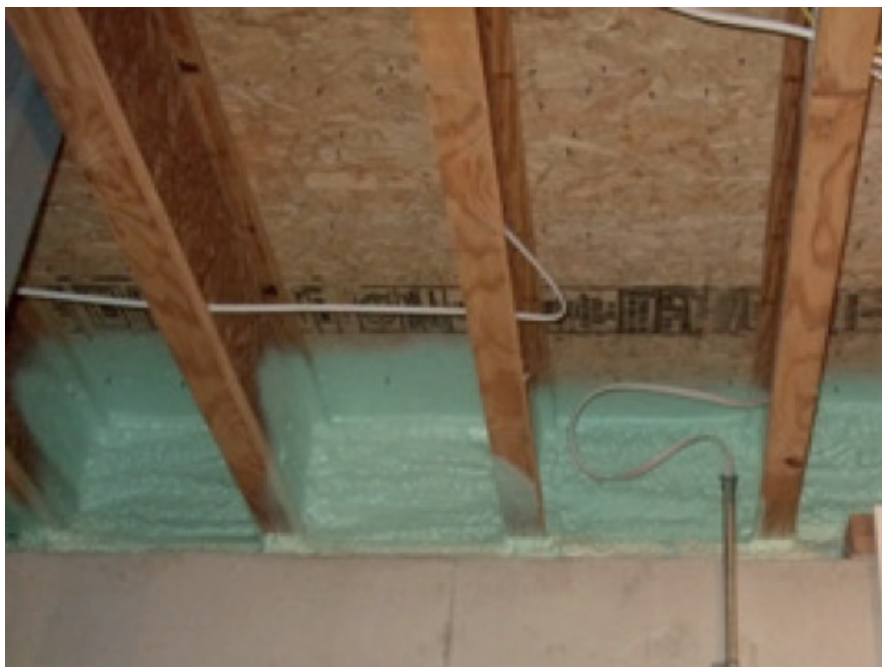
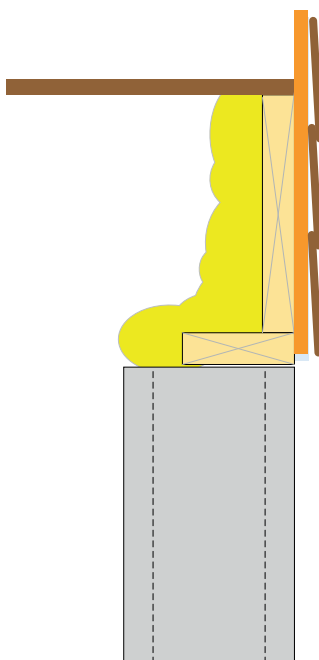
**FIGURE 12.** Closed-cell SPF insulation at the foundation-framing area

SPF is often used by builders of new homes and weatherization contractors in existing homes at the framing-foundation area, and is often regarded as an especially cost-effective and reliable means to insulate and air seal these critical areas\*. Figure 12 shows the installation of closed-cell SPF from beneath the subfloor to the top of the foundation, providing long-lasting insulation, air sealing, and moisture control.

The concern by some pest control and inspection companies with these permanent applications of foam plastic in the rim joist, shown in Figures 12 and 13, is that it does not permit removal of the insulation for traditional visual inspection of the sill plate, band/rim joists or the ends of the floor joists. This challenge can be addressed through use of newer technologies when inspecting for termites.

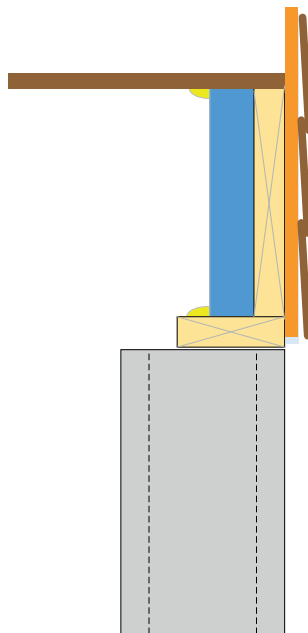
**FIGURE 13.** Foam board insulation and sealant/caulk at the foundation-framing area

Alternative methods of insulating these areas may include the use of cut foam insulation board perimeter sealed with caulk or polyurethane foam sealant, as shown in Figure 13. This approach, is used by some weatherization contractors. It is generally more labor intensive than SPF application, as it requires cutting of the foam board followed by the application of a caulk or sealant. It can be especially difficult application in tight areas and will require cutting around engineered wood I-joists. Like SPF, this application provides long-lasting insulation, air sealing and moisture control. Note that this method does not always provide sealing of the gap between the sill plate and foundation.

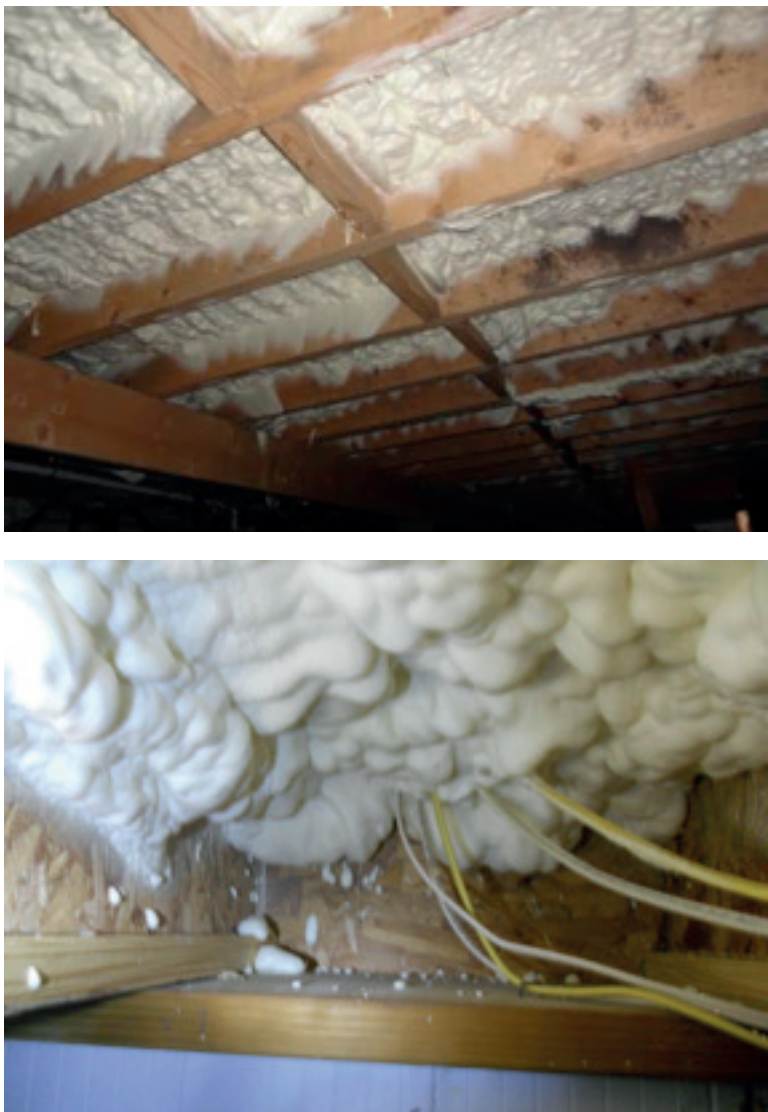
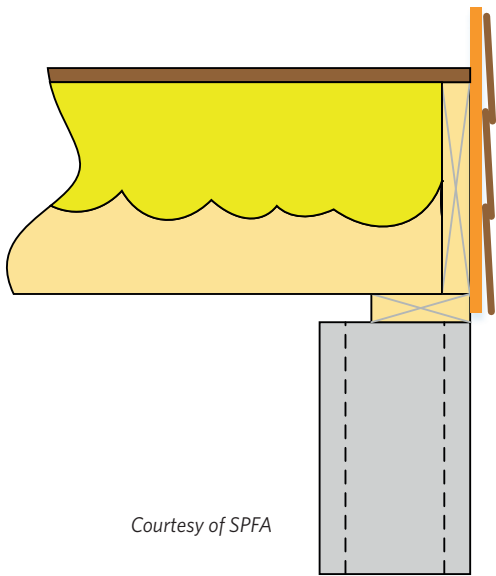
**FIGURE 17.** Installation of SPF below the subfloor allows complete access to the band joist and sill plate for inspection.

As an alternative to encapsulated or conditioned crawlspaces, with the interior of the stem walls covered in foam as shown in Figure 16, SPF can be applied directly below the subfloor and leaving the crawlspace vented. This installation is shown in Figure 17. While this application will typically require more insulation than a conditioned crawlspace, it enables complete access to the band joist and sill plate areas for termite inspections. Application of SPF to the subfloor will help provide air sealing and insulation of the floor assembly, but can limit access to wiring and plumbing. Insulation may need to be added to ductwork and piping located in the vented, unconditioned crawlspaces. Additionally, a vapor retarder may be needed between the SPF and vented crawlspace to help control moisture condensation in hot-humid climates if open-cell SPF is used.
